Aquifer Vulnerability Map of the Pahasapa Limestone (Madison Aquifer), Blackhawk Quadrangle

By
E.M. Francisco, A.L. Lisenbee and A. Davis
2010

The preparation of this map was funded by the West Dakota Water Development District in association with the Department of Geology and Geological Engineering South Dakota School of Mines and Technology

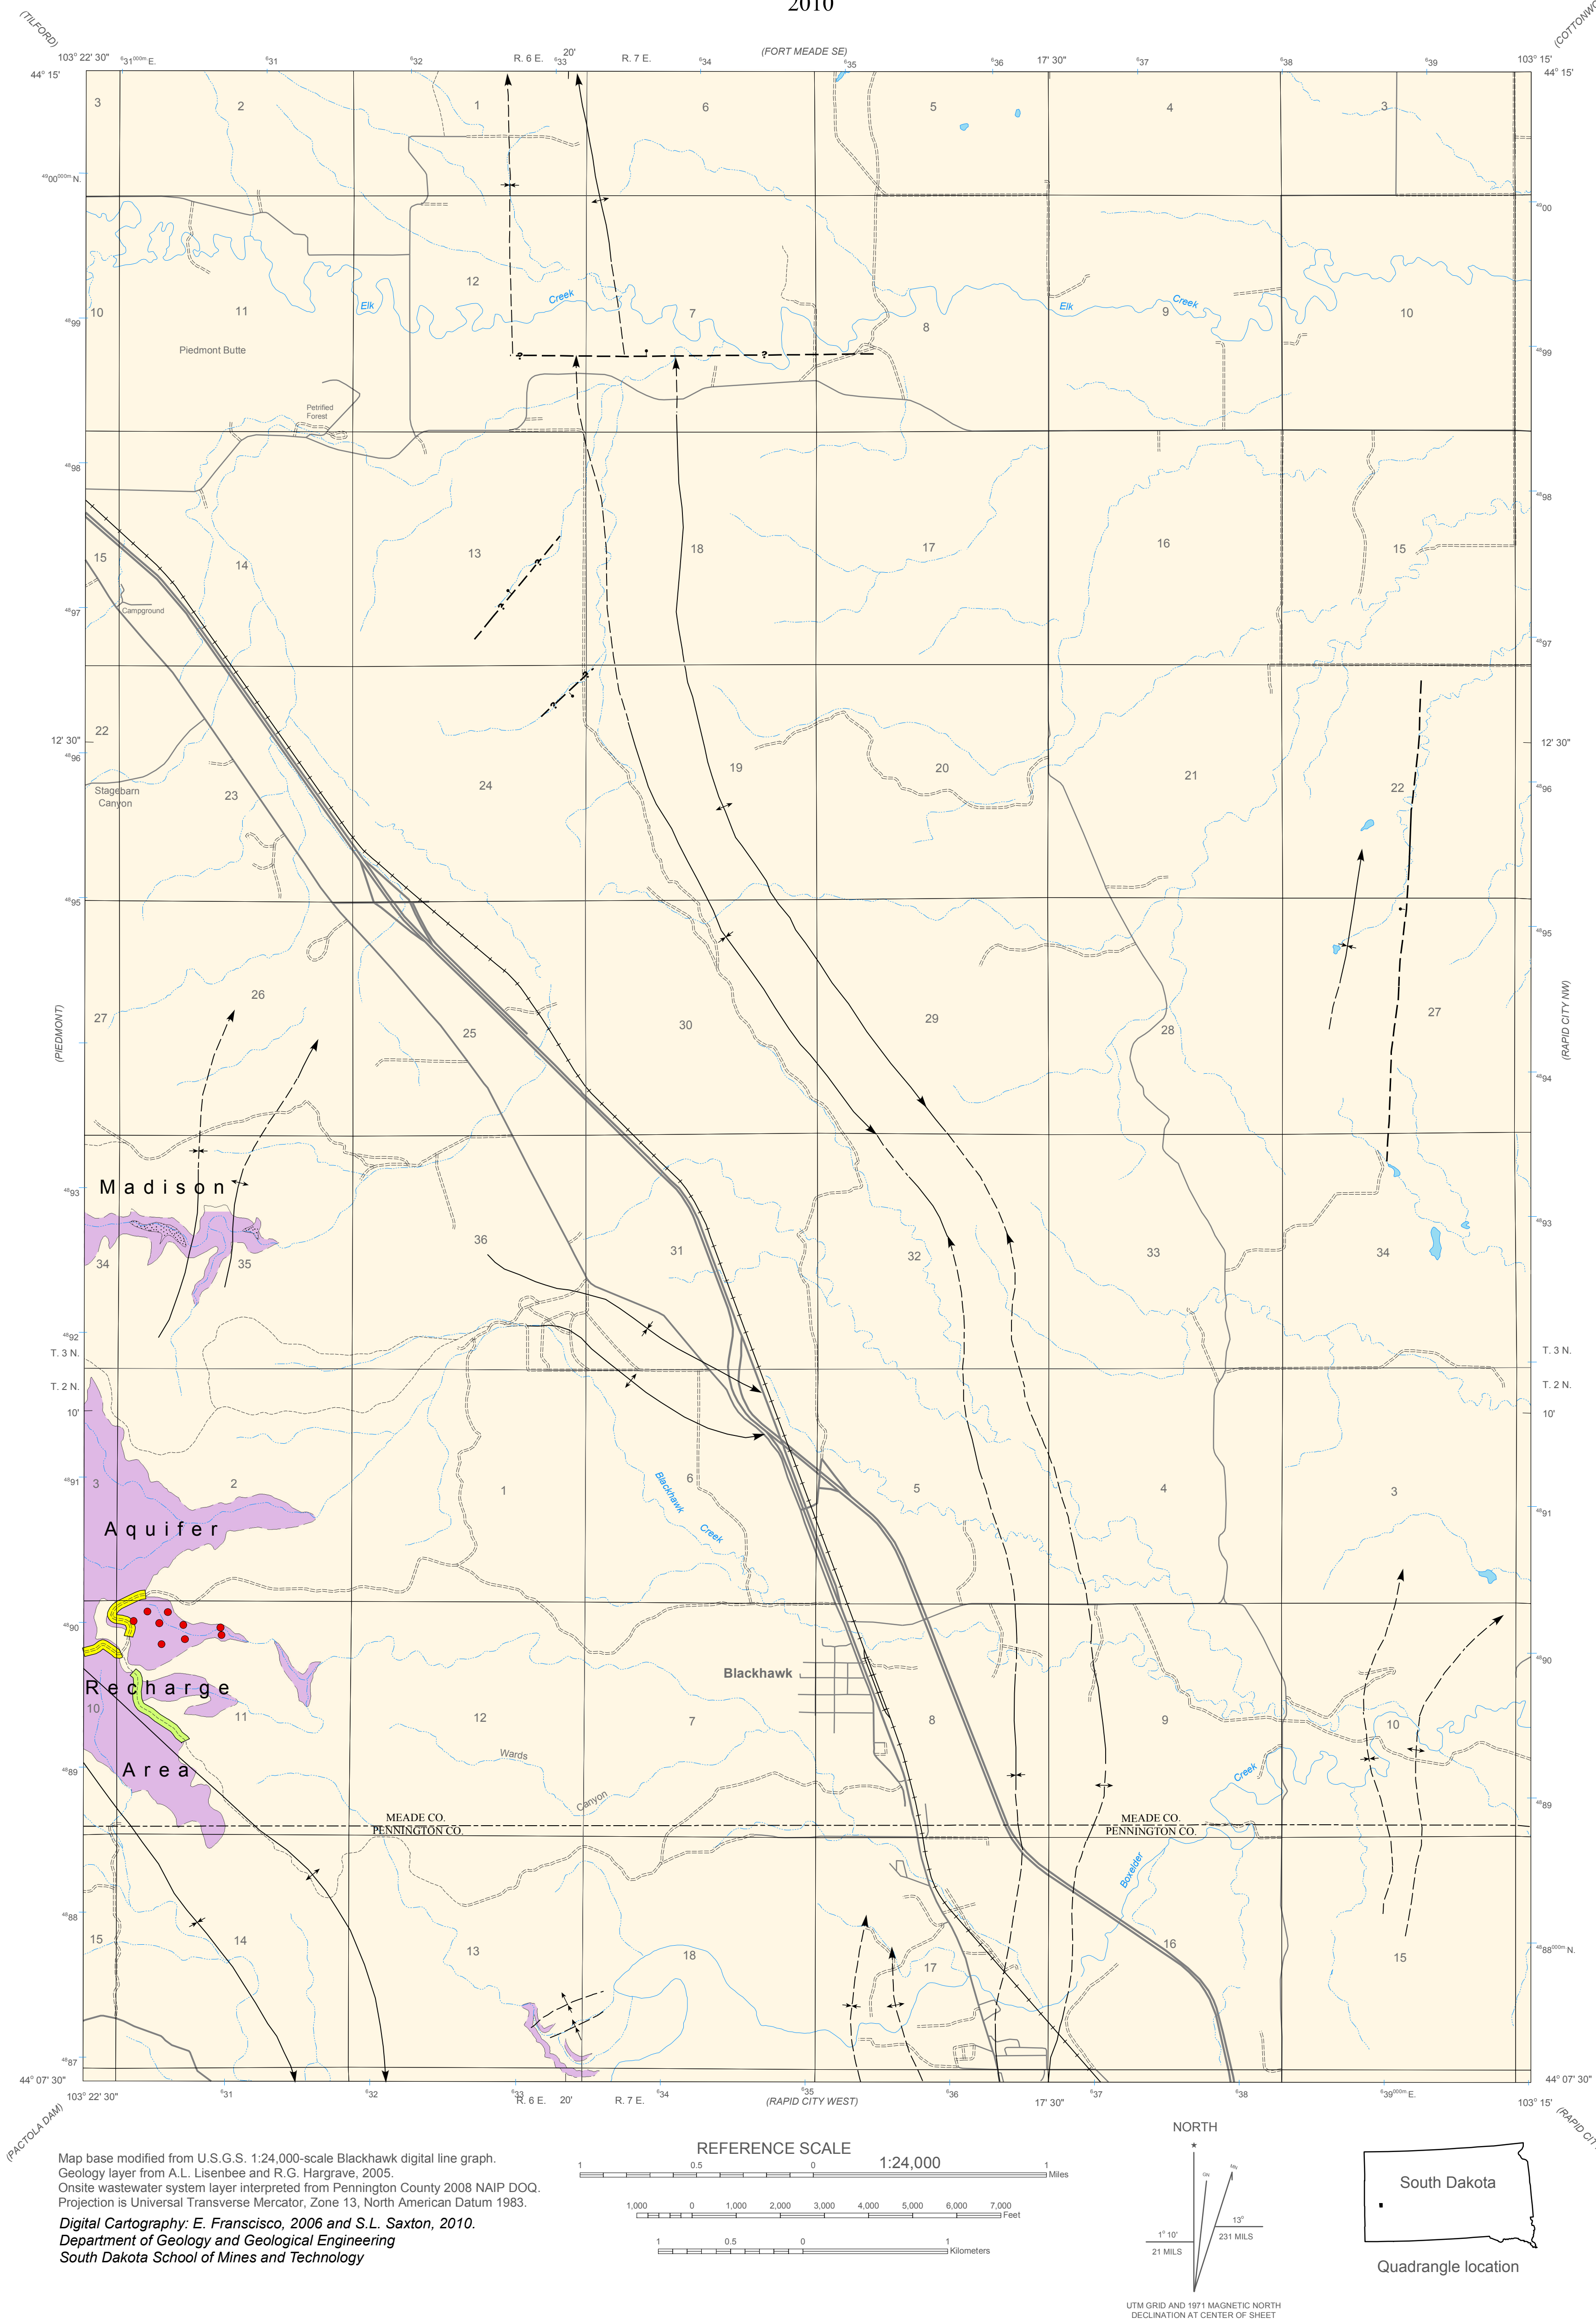
Aquifer vulnerability is the potential or likelihood that any contaminant could reach the ground-water supply, based on designated parameters described below.

Areas of increased aquifer vulnerability due to the presence of on-site septic systems in the Madison recharge area.

Increased aquifer vulnerability due to the presence of roads (buffered 100 feet on either side) in the Madison recharge area.

Recharge Area
Units present include alluvium (Qal) with stippled pattern, terrace deposits (Qt, Qt₁, Qt₂) with coarse stippled pattern, Madison Formation (Mp) with no pattern. Color indicates varying degree of vulnerability; see "Definition of Vulnerability".
