HYDROLOGIC ATLAS OF THE BLACK HILLS, PENNINGTON
COUNTY, SOUTH DAKOTA
BLACKHAWK QUADRANGLE
Aquifer Vulnerability Maps

Aquifer Vulnerability:

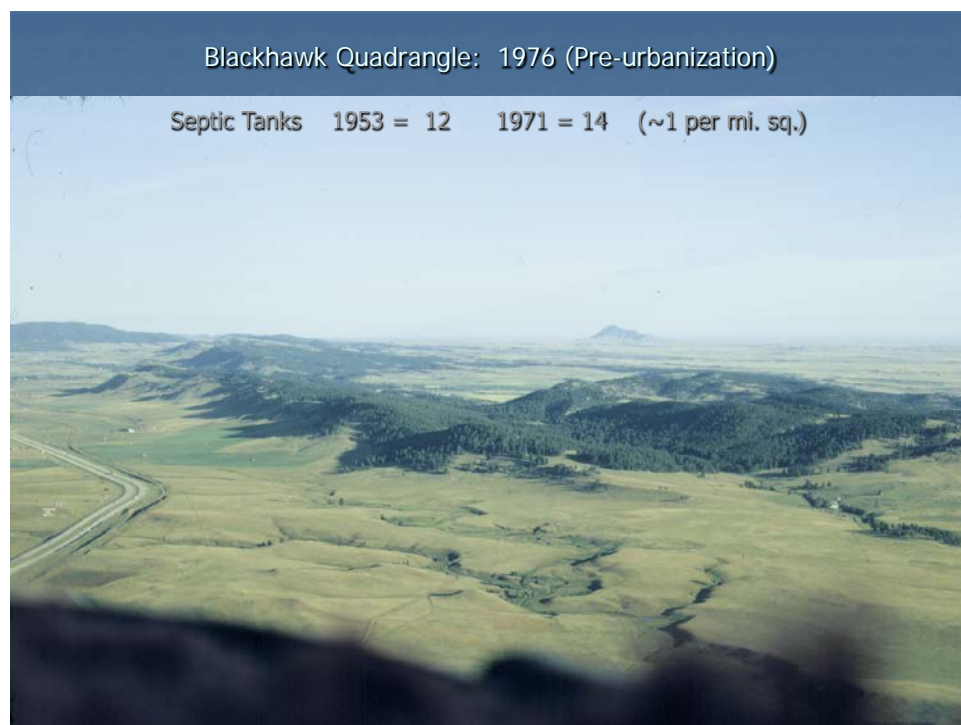
Figure 1. Aerial photographic view of the “Red Valley” and adjacent, pine-tree covered hills underlain by the Inyan Kara aquifer. Photo taken in 1974 prior to major urbanization.

sites (Figure 1). In 1998, based upon areal photographic analysis, this number had increased to 193 and by 2004 to 310.
