# HYDROLOGIC ATLAS OF THE BLACK HILLS, PENNINGTON COUNTY, SOUTH DAKOTA HILL CITY QUADRANGLE

## Aquifer Vulnerability Map

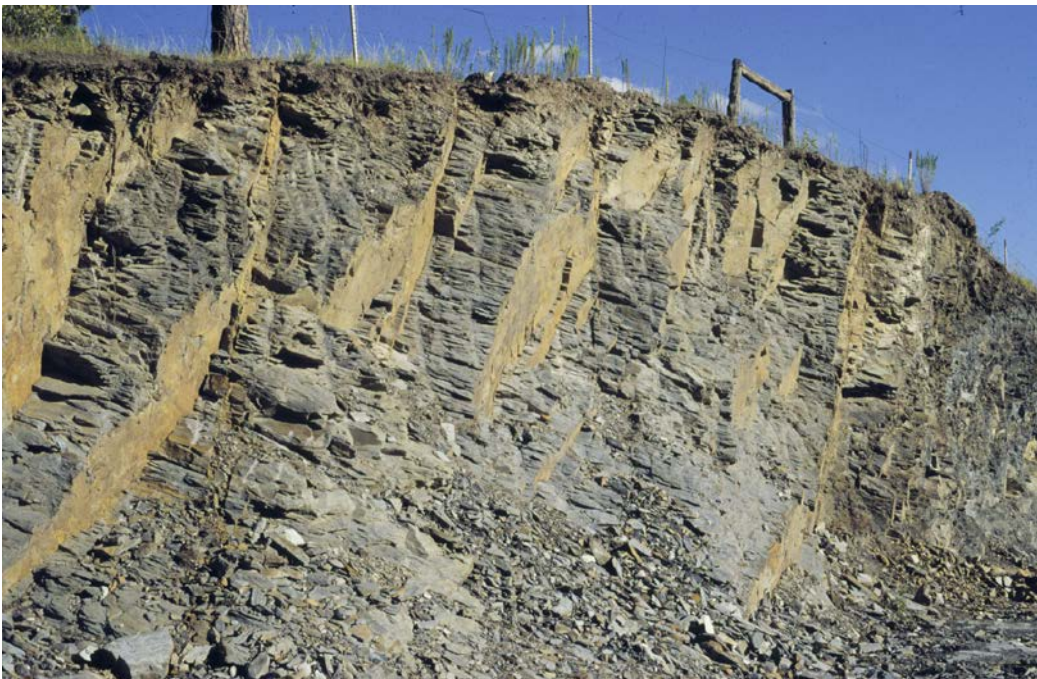
Figure 1. Parallel fractures in metagraywacke in the east side of Hill City. Orange, rusty color indicates movement of groundwater along fractures.

Ground water in the area of the Hill City quadrangle is contained either in fractured Precambrian crystalline rocks (Figure 1), e.g., schist, quartzite and metabasalt, or in shallow sand and gravel deposits along streams.

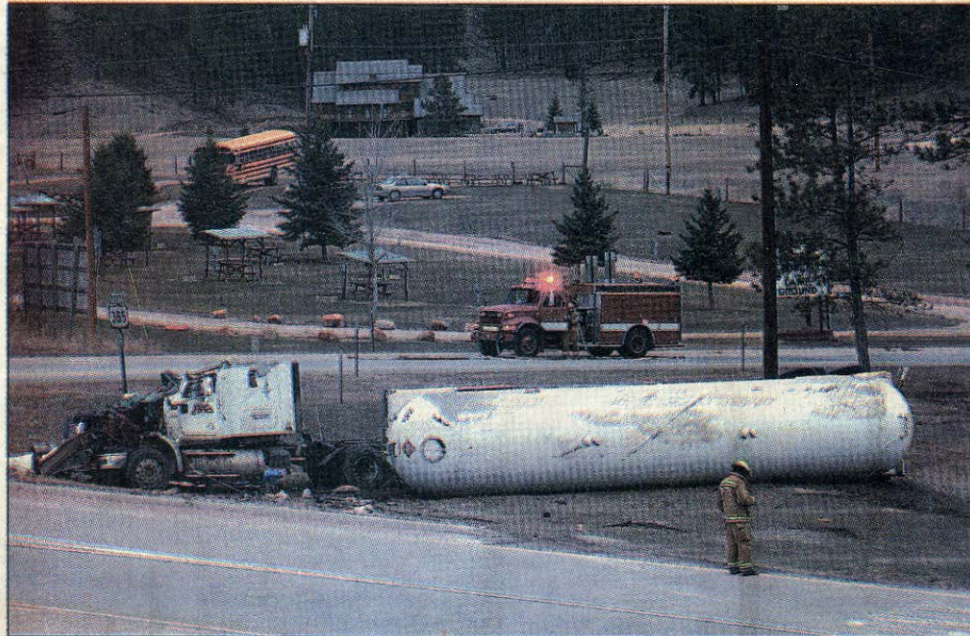
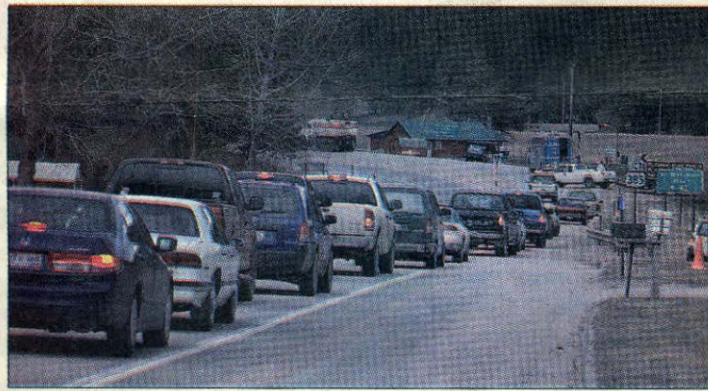
A tractor-trailer loaded with 9,000 gallons of propane overturned at the corner of U.S. Highways 16 and 385 on Saturday afternoon. The driver was taken to the hospital, but his injuries are not believed to be serious. After the tanker overturned, law enforcement closed the intersection. Traffic backed up for a quarter of a mile at one point.

Figure 2. Accident at the intersection of U.S. Highways 16 and 385 involving a propane delivery truck. This occurred along the flood plain of the nearby Spring Creek.

One hundred meter (330 feet)-wide buffer zones along roads are assigned values ranging from **low**, on dirt roads with lesser traffic, to **high** along paved road on the flood plain deposits along creeks. Vehicles, e.g., gasoline and propane trucks, and others carrying chemicals, travel U.S. Highway 16 and, to a lesser extent, Highway 244 both which follow valley bottoms for extensive distances. Any substances released from such tanks (fortunately none were in the example shown in Figure 2—photo from the Rapid City Journal), or from vehicles themselves, have the potential to contaminate ground water in the underlying aquifer.
